Subject: RE: Gold King Mine Spill - brief background and initial EPA Region 9 response (internal - do

Below is some background information and initial steps that EPA Region 9 is taking to respond to the Gold King Mine spill. Approximately 3 million gallons of mine wastewater/drainage/sludge was released from a dormant mine (Gold King) and flowed into Cement Creek which is a tributary of Animas River. The Animas River connects with the San

When our river turned orange

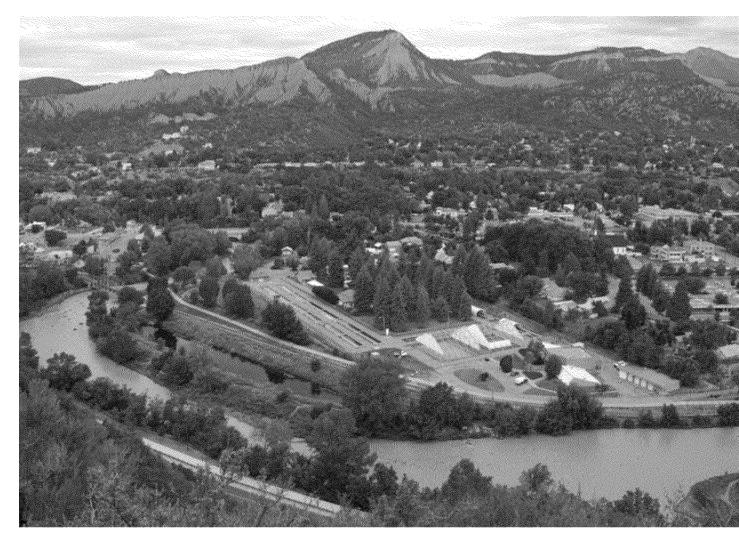
Samples taken by the EPA as the plume moved through show that it has high levels of heavy metals.
